ALUMINUM BONDING RESEARCH PROJECT

Draft #1

This report deals with the experimentation, and research work done in the laboratory in the investigation of methods for bonding of ferrous materials with aluminum alloy. All data presented herein, is the result of actual experimentation made in the laboratory with the apparatus and equipment of the company. All opinions and conclusions contained in this report are those of the author, and have been substantiated wherever possible by direct experimentation. Several items discussed require further work to prove them out under actual operating conditions in the foundry. The basis for this report was to determine if the several possible bonding methods could be accomplished even under laboratory conditions, and to obtain as much technical information as possible as to the advantages or disadvantages of each. It must be pointed out, that in some cases, a method may be satisfactory with a small sample under strict laboratory conditions, yet ^{it} will not be practical under actual foundry operations in production. Much important information has been obtained from this experimentation that could save valuable time in the future if this work wa

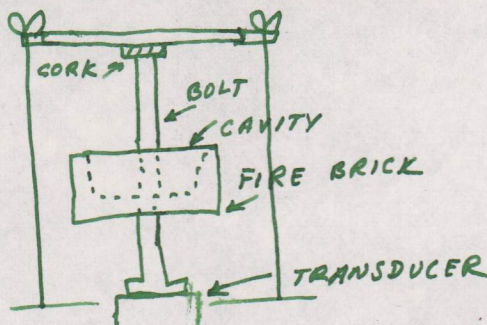
FIG. 1.

The suggestion that a possible bond might be obtained with the use of ultra-sonic excitation in the place of flux or metallization was explored. A clean steel bolt was obtained. After cleaning to remove all oxides and hydrocarbons (Grease oil) no contact with hands or organic materials was permitted. The bolt was pre-heated to a temperature of approximately 400° F. The pre-heat temperature was kept below the zone where visual oxide formation takes place. 43 alloy aluminum was melted in a graphite crucible to 1500° F. (All temperatures were pyrometer measured and controlled) The bolt was attached to the ultra-sonic transducer as indicated in fig. 1.

Sealing wax was used as the couple medium because of its higher melting temperature. The sample mold was constructed from a section of Silocel insulation brick. This type of mold was used to provide the longest cooling time for the aluminum alloy, so as to allow a long period of ultra-sonic excitation to the sample. The ultra-sonic energy was applied and the aluminum metal poured as quickly as possible. It was noted that as the aluminum was being poured, the resonance of the assembly changed. This may be due to either damping action of the molten aluminum or a thermal expansion of the steel bolt as it absorbed heat from the aluminum. An attempt was made to prevent this expansion by the insertion of a cork spacer at the top of the bolt between the support and the bolt. However, this was not as effective as desired. This change of resonance would present problems in

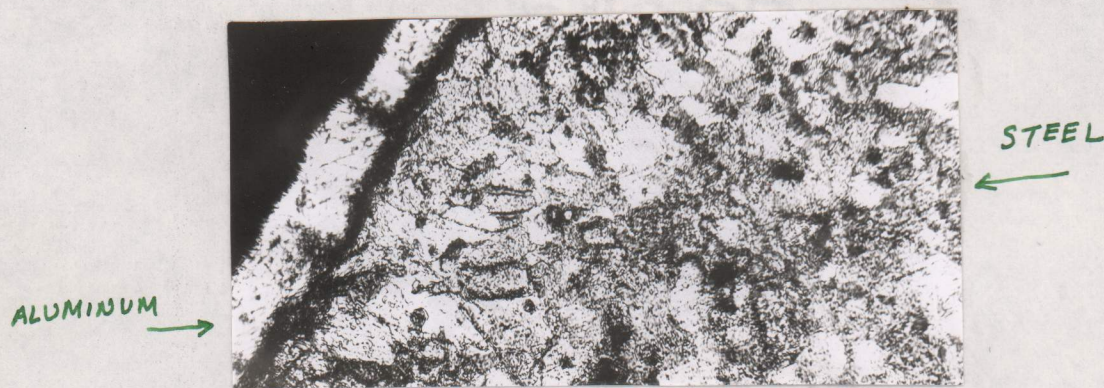
FIG. 2
250X

production casting conditions, since it would be impossible to predict the resonance of the system before the sample was poured. The ultra-sonic energy was continued for about one minute until the surface of the molten aluminum started to solidify. The energy was then discontinued and the sample allowed to cool normally. The sample was then sectioned and examined microscopically. There was a definite indication that the aluminum had "wetted" the steel. However, this condition was not continuous around the entire diameter of the bolt. Fig. 2 indicates the intermetallic layer next to the steel. The dark area is void since the aluminum alloy was broken away from the steel intentionally.

The bolt was then sectioned along its length as indicated from fig. 2. This revealed a coating along part of the surface near the place where the aluminum remained molten longest, (Area of longest ultra-sonic excitation). This condition is illustrated in fig. 3.

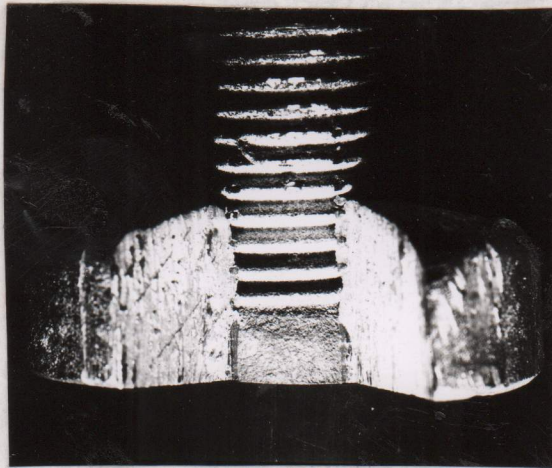
FIG. 4
3X

A second steel bolt was obtained but coated with the metallized aluminum. This bolt after coating, was run through the ceramic Selsas furnace in the same manner as all other previous samples. After cooling, it was set up in the exact fashion as the sample in experiment 1. All conditions as to metal alloy, temperature and pouring were identical to the first sample. The same damping conditions were noted as in the previous run. Our problem was to determine if a metallized bolt would provide any advantage over the uncoated one. After sectioning this sample and examination with the microscope it was noted that no bonding took place between the aluminum and the metallized layer. A good bond was formed between the metallization and the steel. The sample was then sectioned along its length as in the first experiment. This indicated a discolorization on the surface of the metallized layer, with no attachment of the 43 alloy. This can be seen in fig. 4. This shows there is no attack on the metallized layer from the aluminum alloy. Probably, the oxides on the metallized layer act as an insulator and prevent the alloying of the aluminum. The ultra-sonic energy does not seem to break this oxide layer down. It was also noted in both experiment 1 and 2 that considerable gas was formed in the metal.

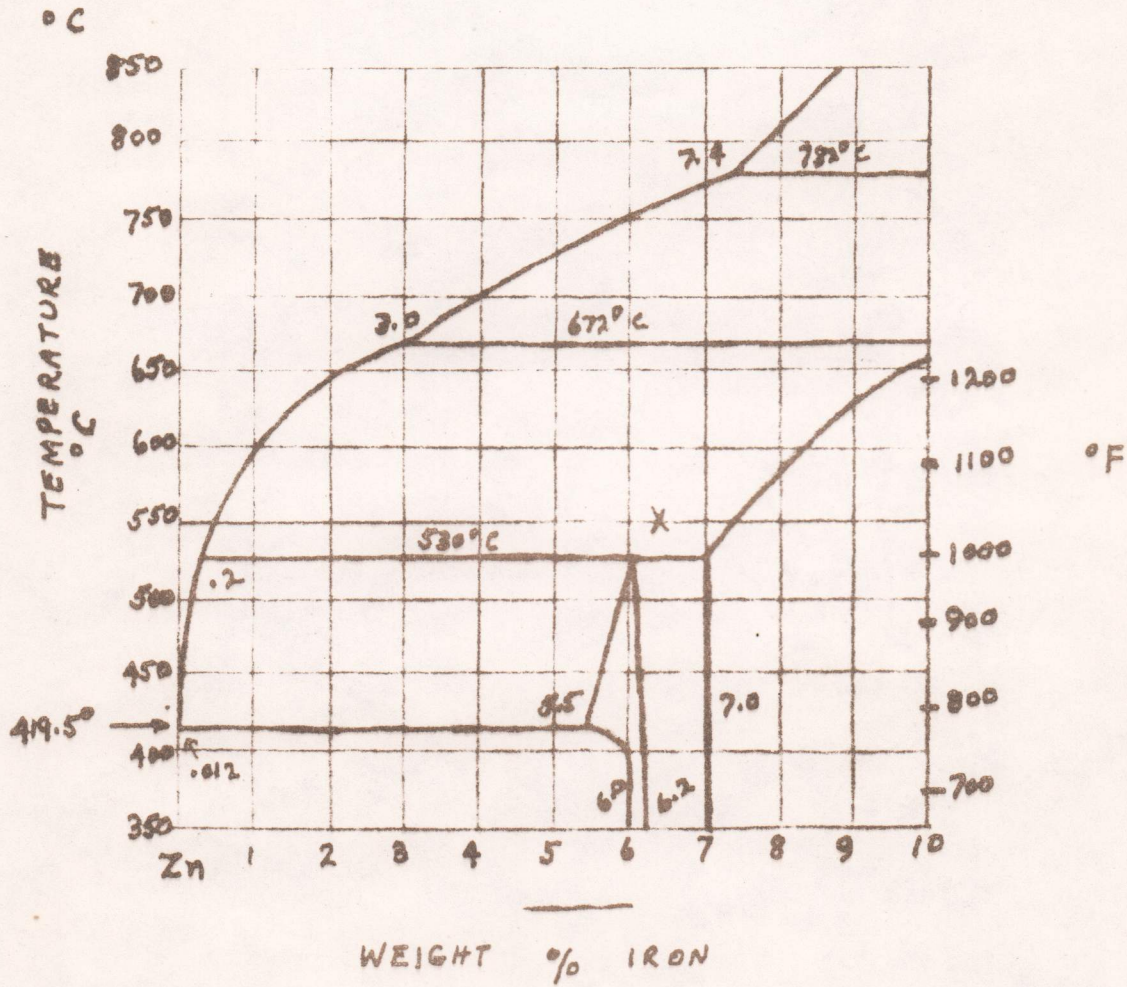
FIG. 5

IRON - ZINC

It was thought that some other metal might be substituted for the aluminum metallization that had properties more suited to alloying with aluminum. This idea evolved into the MONARCLAD system. Zinc and zinc alloys such as Zamak were considered as substitutes. It is well known, that zinc will coat iron base materials with great ease. This is similar to galvanization. There is a definite alloy condition between zinc and iron that starts to form at rather low temperatures. See fig 5. It can be seen that this alloying starts around 980 to 1000° F. (The melting temperature of zinc is around 800° F.) At temperatures of 950 to 1050°, the attack of zinc on iron is very rapid. This condition is in evidence on our pyrometer protection tubes, and even on our zinc melting pots. To prove

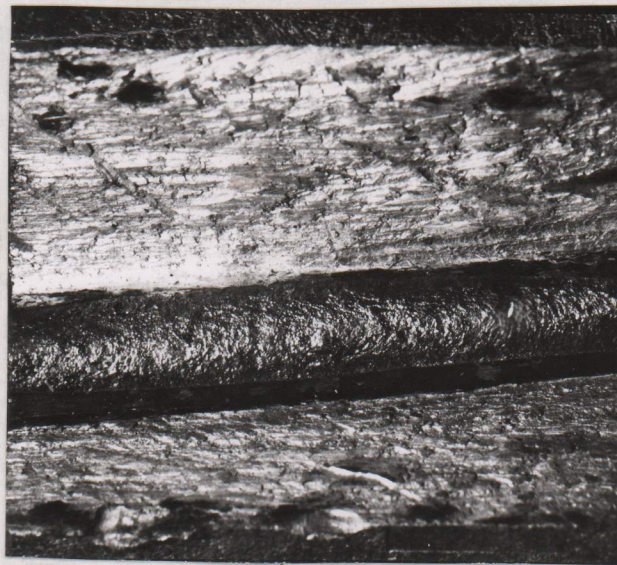
FIG. 6
25X

← ALUMINUM

← STEEL NAIL & COATING

this out, several common steel nails and steel bolts were subjected to coating of zinc by a hot dip method. The procedure is as follows. Zamak alloy was melted in a crucible to 1000° F. ALCOA #33 braze flux was added to surface of the molten zinc, and the steel nails and bolts were inserted under the surface of the zinc. The entire crucible was agitated and the metal stirred. The steel items were removed one by one and rapidly shaken to remove all excess zinc. The agitation was to assure complete coating of the steel. The steel was left in the molten zinc for several minutes. The small amount of flux that adhered to the surface of the coated steel was removed by immersion in water since the flux is a water soluble type. Several of the steel samples were left with a thick coating of zinc to determine if a thick or thin coating had the better bonding properties. The coating of steel without the use of any type of flux was also tried. It is possible to coat a steel sample with zamak without flux. However, the steel must be very clean and must be in the molten zinc for a longer period of time. The actual bonding is the same if flux is used or not. The only advantage of flux is that the steel is processed more rapidly. The particular use of ALCOA #33 flux provides only one advantage. The flux has a melting temperature of about 1000° F., and does not decompose rapidly in zinc. This flux was intended by ALCOA for use as a braze flux for aluminum. However, any good flux such as ammonium chloride, zinc chloride or even sodium potassium chloride mixtures or any combination of these will be just as satisfactory. The soldering type low melting fluxes can also be used, rosin, ammonium chloride/zinc chloride, but these have a tendency to react with the zinc since they are used for cleaning zinc metal and will produce dross that has to be removed from time to time. A organic flux might also be considered for this application. All the above mentioned flux material was tried, with the exception of rosin and all worked about the same.

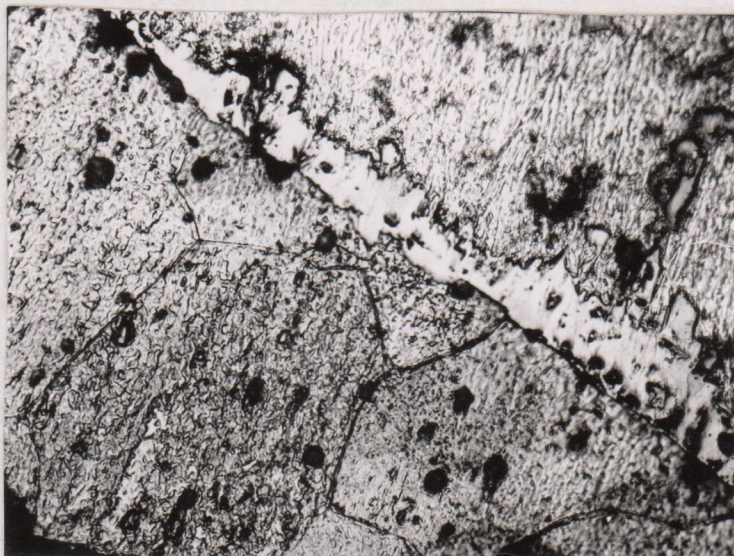
FIG. 7
250X

← STEEL

← ALUMINUM

← INTERFACE

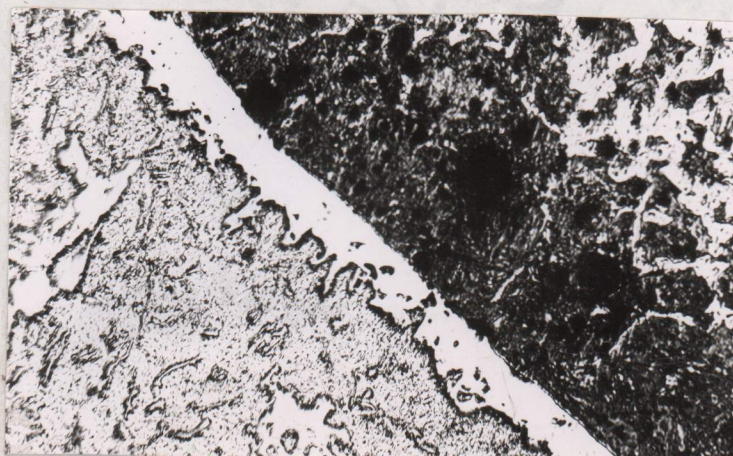
FIG. 8
250X

← ALUMINUM

← STEEL

← BURNED STEEL

← INTERFACE

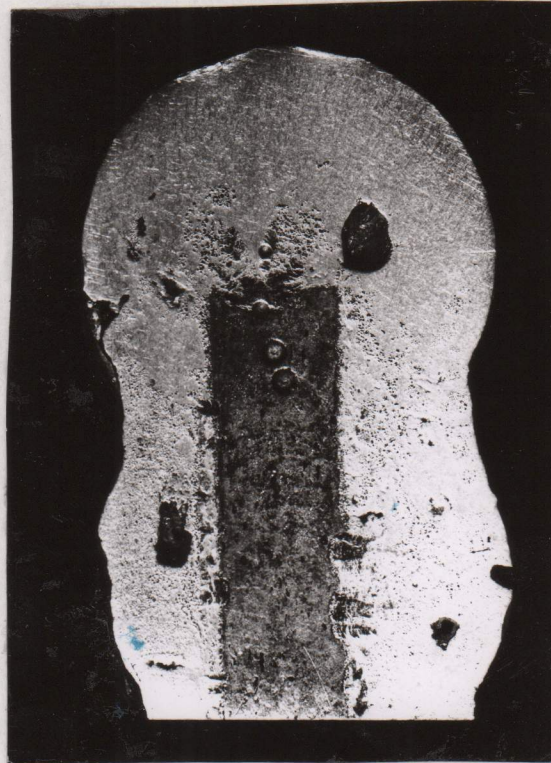
FIG. 9
5X

similar to experiments number 1 and 2. 319 aluminum was heated to 1600° F. and cleaned to remove all oxides from the surface of the metal. The aluminum alloy was poured into the mold and allowed to cool. The conditions of the mold were such that cooling of the metal was very slow. The reason for selecting a very long cooling time was to determine if prolonged contact of the hot molten aluminum would remove the bonding layer from the surface of the cast iron. In this experiment it was thought that flux would aid in the alloying of the aluminum to the zinc, so that considerable flux remained on the surface of the zinc coated cast iron. After cooling the sample was removed from the mold and the surface (End) sectioned. It was noted at once that there was a hard bright layer between the cast iron and the aluminum. It was also noted that there was considerable gas present in the casting, probably due to the excess flux used, and that there were small inclusions scattered over the entire area of the aluminum but greater in concentration near the coated surface of the cast iron. These inclusions had the appearance of being the same as the layer next to the cast iron itself. Microscopic examination indicated a bond between the aluminum and the cast iron. This layer was uneven and very hard. The inclusions had the same appearance as the interface layer and were assumed to be the same composition. No free zinc could be found anywhere over the surface of the casting. The visual section of this casting may be seen in fig. 9, and the microscopic view in fig. 10. The voids contained traces of flux crystals.

CAST IRON BRAKE DRUM
INSERT

The sample was then sectioned along its length and struck with a hammer to remove the out aluminum. Again, several hard blows were required to remove the aluminum and the broken surface of the cast iron indicated a tearing away of the aluminum from the iron. It would be concluded that a definite bond was formed between the cast iron and the aluminum. It could also be concluded that very high metal temperatures are not ~~required~~ ^{DESIRED , AS WELL AS,} as prolonged cooling time. Excess flux is to be avoided as much as possible. After several days, it was noted that the flux caused corrosion to the cast iron. Any flux imbedded in the metal in contact with moisture will cause this corrosive condition and should be avoided.

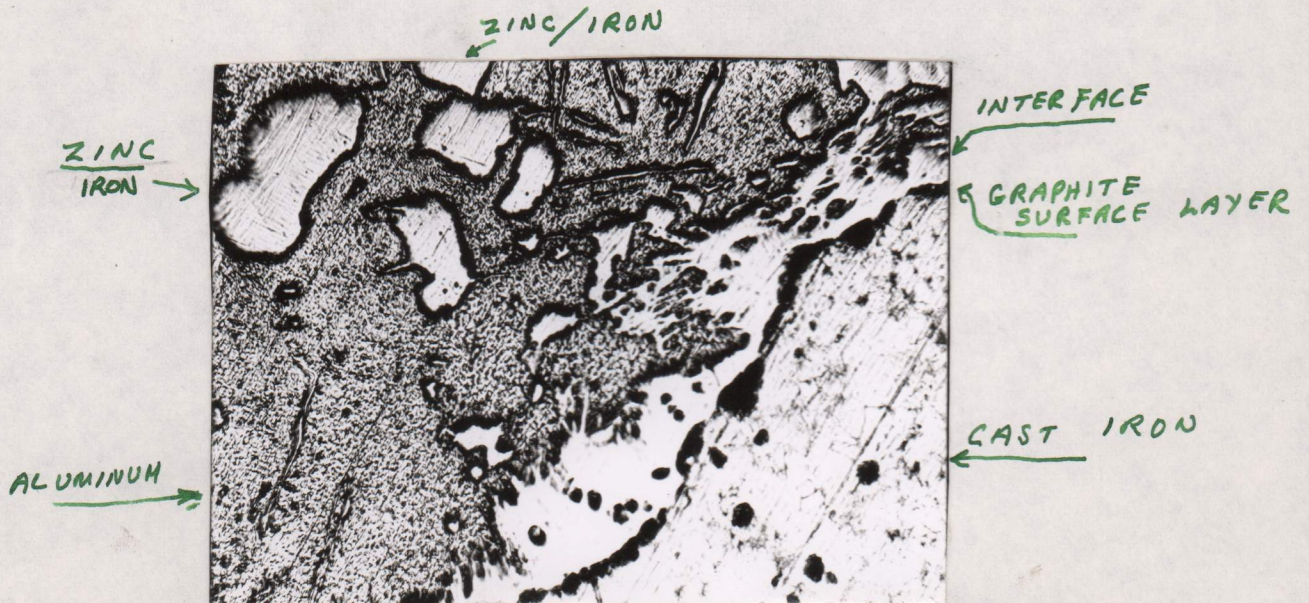
FIG. 10
250X

GRAPHITE

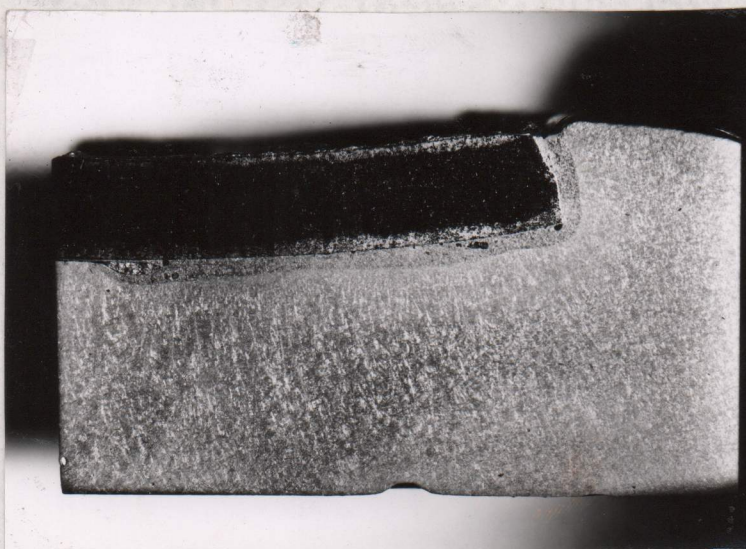
FIG. 11 - 5X

A distinct layer could be seen next to the cast iron. See fig. 11.

Microscopic examination indicated that a bond was formed, but this bond had several cracks or pockets along its length. The band visible along the entire length of the cast iron surface in fig. 11, was probably a layer of zinc/aluminum alloy. This can be seen in fig. 12.

The cast iron was very adherent to the aluminum around it, and gave the same properties as before. Several blows were required to separate the cast iron from the aluminum. We are unable to explain the cause for the separation and inclusions along the surface of the cast iron. It may be possible that this was caused by the flux layer on the coated iron, or unequal thermal expansion between the cast iron and the coating. Several other sections of cast iron were obtained and cast. Both with Monarch zinc and metallized with aluminum. The only success was with the zinc coated types and these were not too satisfactory. The problem is with the flux, too much is bad, poor bonding and not enough will cause coating of the cast iron with graphite. Considerable work will be required on this problem before satisfactory results can be obtained.

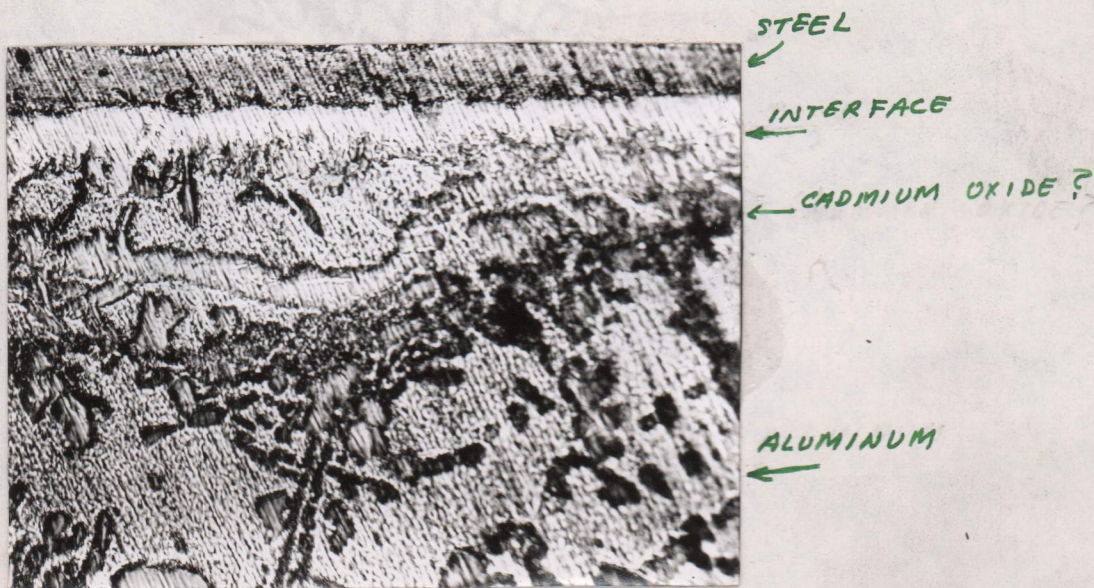
FIG. 13
250X

Unfortunately, only one Cadmium plated rod was available for experimentation. It would have been an advantage to have at disposal a Cadmium plated cast iron sample to experiment with. The Cadmium plated steel rod was pre-heated to about 500° F. (This temperature was estimated). A pre-heated permanent mold was used, and the rod placed at the bottom of the mold. 319 alloy at 1350° F was rapidly poured into the mold. The sample was cooled, sectioned and examined. Fig. 13 indicates the condition of the bond. A definite bond can be seen along some of the length of the steel rod. However, there are areas where the Cadmium plate was not completely removed, probably because of the lower temperature used in casting. In fact, there is a pronounced departure line where the plate was not removed. Since no other plated sample was available, this experiment could not be further pursued. It would seem from the above work that this method has some very definite possibilities, but requires more work to determine correct and optimum temperatures and casting conditions. This is one of the simplest systems devised for formation of a bond, since no flux or surface preparation is required other than the Cadmium plating. This may also be the key to the graphite problem in cast iron.

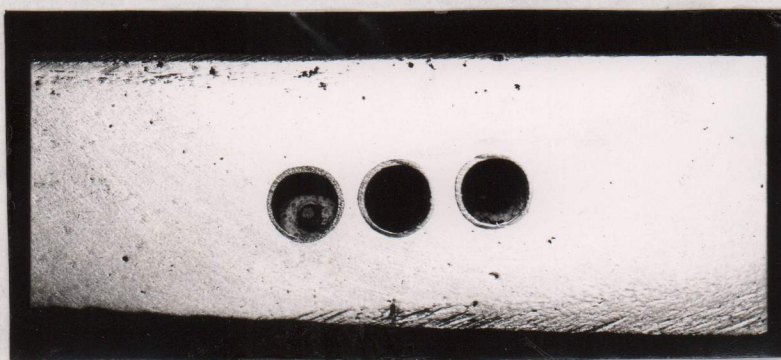
FIG. 14
2X

Unfortunately, the calrod in sample #3 developed a short, and burned out. This was probably due to the excessive ^{CA} heating time, since no thermostat was used on any of the castings. In all cases the power was applied directly to the calrods. Samples # 2 and # 3 were then sectioned to examine the interior bonding to the calrod. Fig. 14 indicates the condition of filling of 319 completely around the coated calrod, with no visible voids. Microscopic examination indicated an excellent intermetallic bond as well.

CROSS SECTION
THROUGH CASTING

It could be concluded from this experiment that there is a very good possibility for the use of MONARCLAD on steel calrods. However, much further work would have to be done on this phase to determine all the probables and variables that might be encountered.
